TRANSPORTATION RESEARCH CENTER

**Indiana University
Bloomington, Indiana 47403-1599**

ON-SITE AIR BAG INVESTIGATION

**CASE NO. - 96-16
FLEET - PRIVATE VEHICLE
LOCATION -
ACCIDENT DATE -**

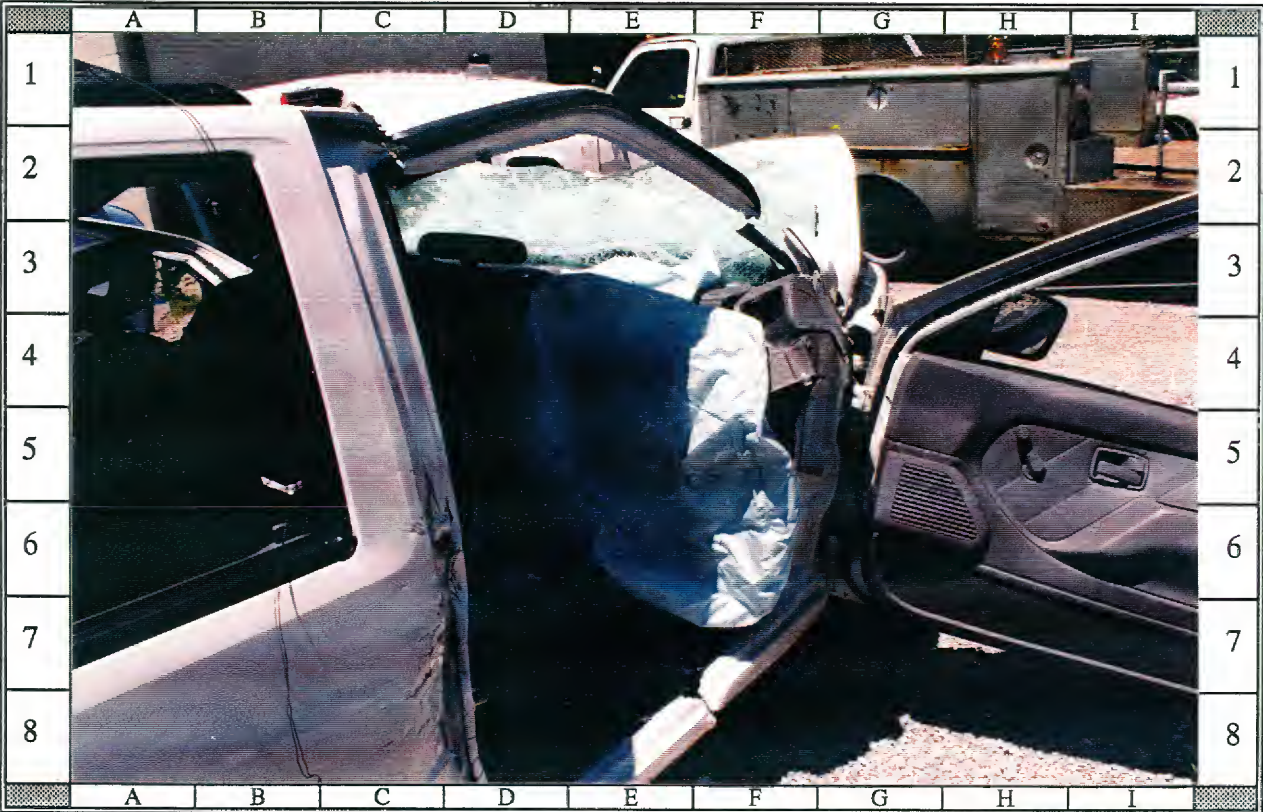
68: Interior surface of Case Vehicle's right front door showing no contacts; NOTE: deployed passenger air bag, cut "A"-pillar, and windshield folded onto hood

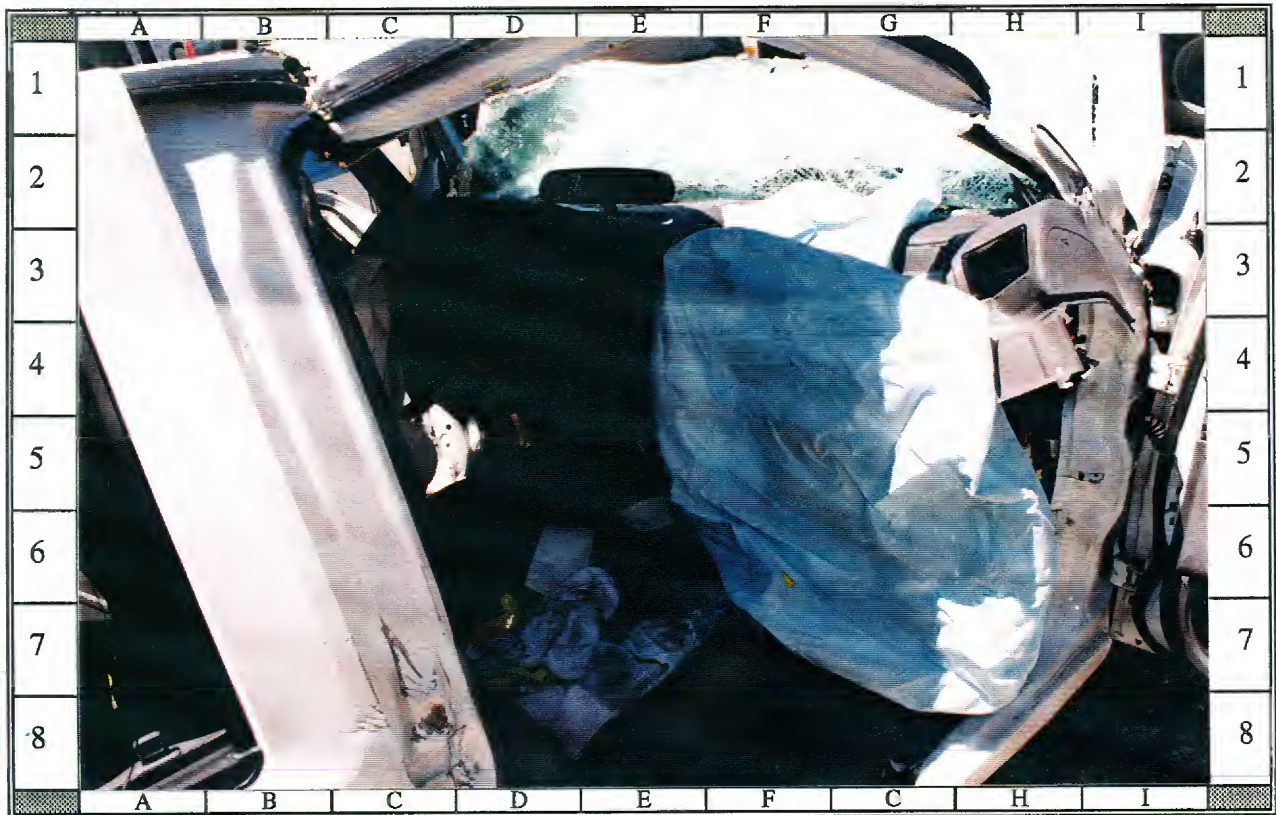
69: Case Vehicle's right front seating area viewed from ~ 60 degrees back of right showing deployed air bag and dash damage; NOTE: extrication damage

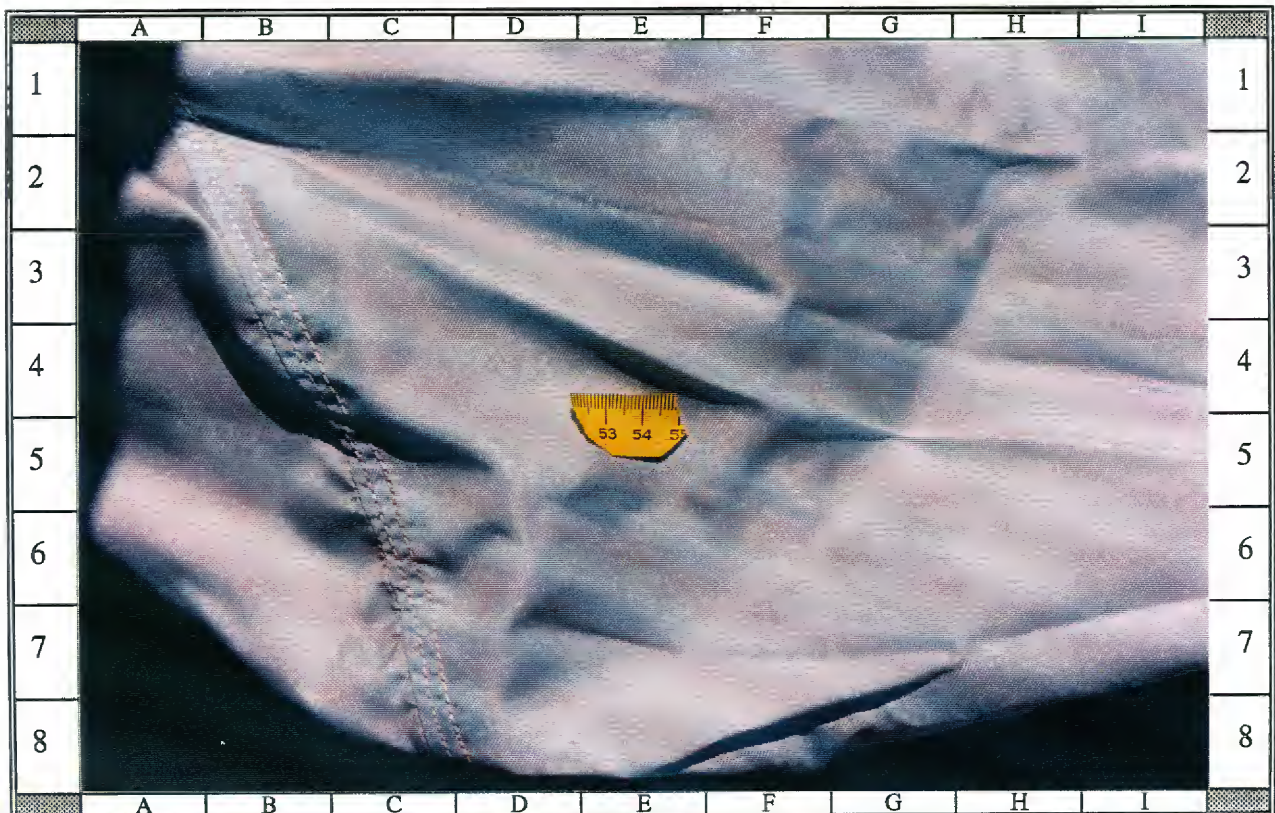
70: Close-up of Case Vehicle's deployed right front passenger air bag showing possible occupant contact on air bag's lower left quadrant

For the case vehicle's front right passenger, this contractor's conclusion is that she was possibly fatally injured by her deploying air bag; however, the evidence is far from conclusive. The front right passenger's seat track was most likely located at its rearmost position, thus putting her as far back as possible from her deploying air bag. The front right passenger's autopsy indicates that her cause of death was a deceleration injury (see footnote #16). According to the resident pathologist who performed the autopsy on the front right passenger, the pathologist thought that the fatal lesion most likely resulted when the occupant's head hyperflexed backwards over her seat back during the occupant's rebound from her successfully used safety belts. However, the pathologist did not know at the time of the autopsies that air bags were involved in the crash. In addition, the pathologist did not know that the case vehicle was equipped with adjustable head restraints that were at least adequately positioned; see **SELECTED PHOTOGRAPH #39**²⁰. Given the passenger's short stature [168 centimeters (66 inches)], age (49 years), documented injuries (i.e., atlanto-occipital subluxation resulting in a flexion type²¹ laceration of her basilar artery at the level of the medulla oblongata and most likely a spinal cord lesion), and the fact that she was most likely deceased at the time the emergency medical technicians arrived, this contractor considered the front right occupant as a likely candidate for having been fatally injured by her air bag. However: her seat was most likely positioned in its rearmost track position, there is no clearly discernable contact evidence on the front right passenger's air bag, and as the resident pathologist points out, there is no evidence of facial injury from contacting the

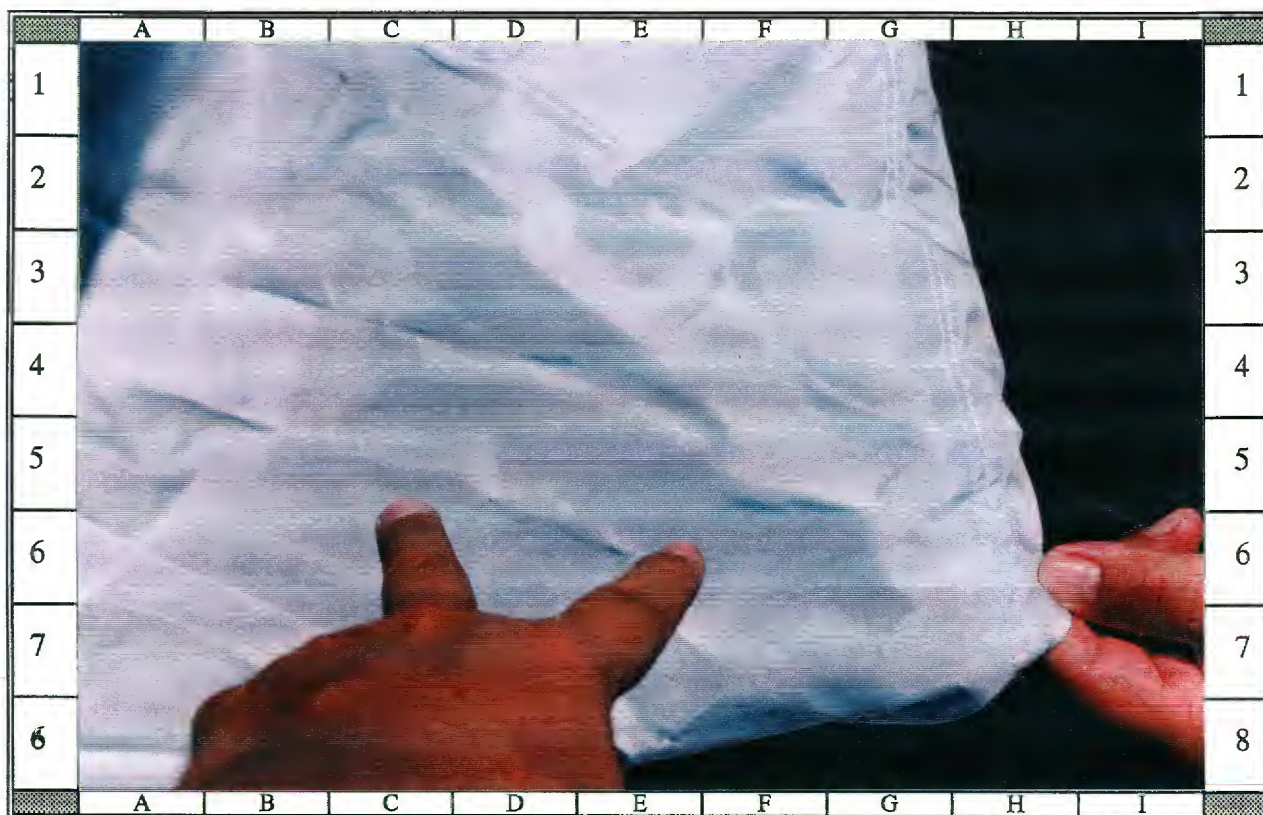
71: Close-up of Case Vehicle's deployed right front passenger air bag showing possible occupant contact (i.e., between fingers) on air bag's lower right quadrant

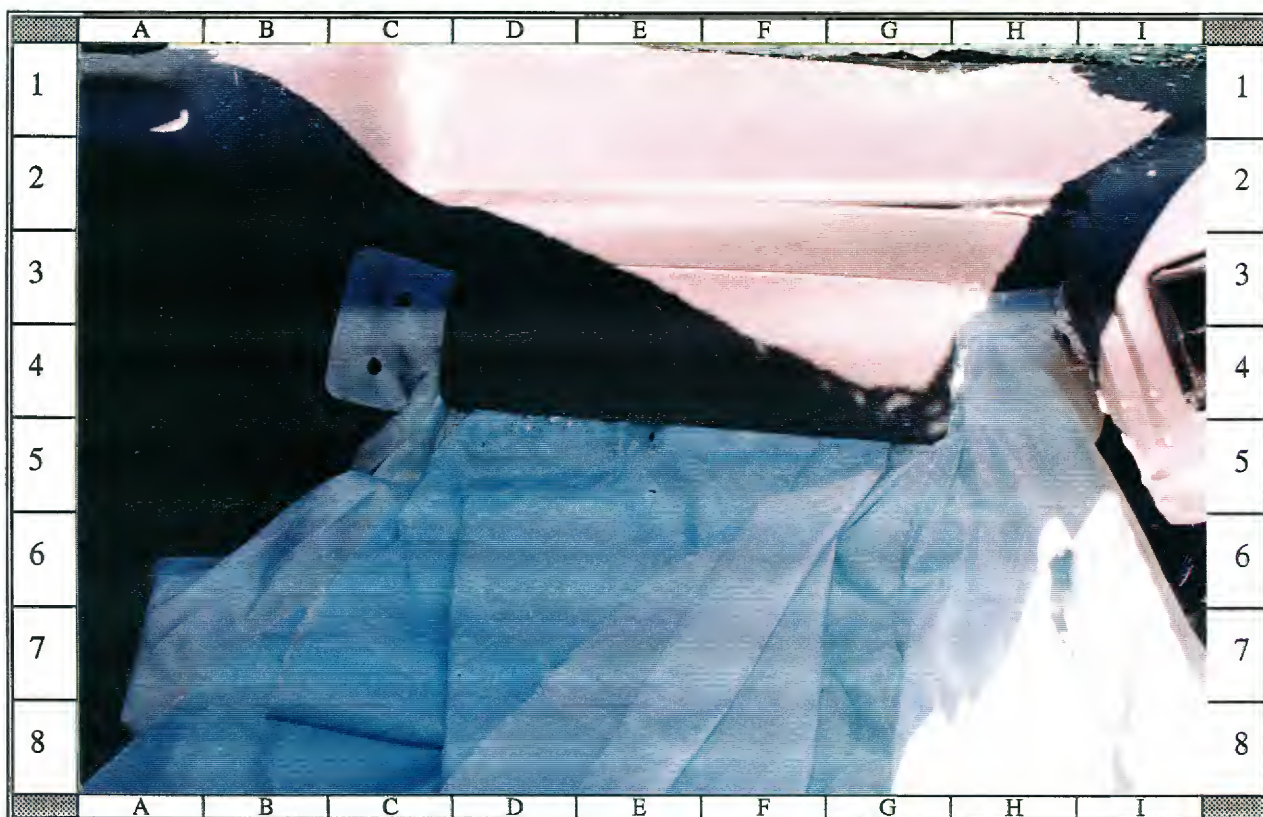
72: Close-up of top cover flap from Case Vehicle's right front air bag module;
NOTE: no contact evidence on cover flap and tear to right dash (cells H2--I5)

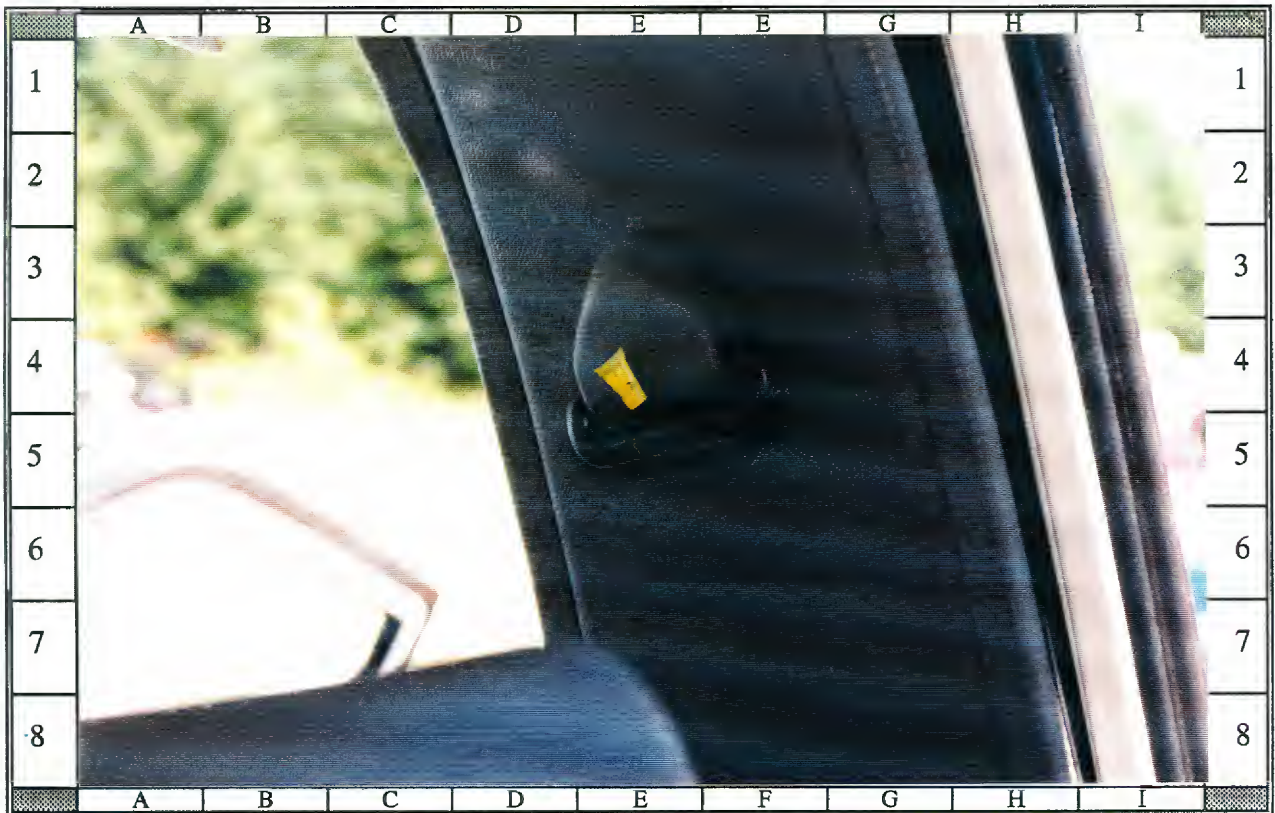
73: Close-up of Case Vehicle's right front "D"-ring on right "B"-pillar; NOTE: "D"-ring shows evidence of loading from right front passenger's safety belt

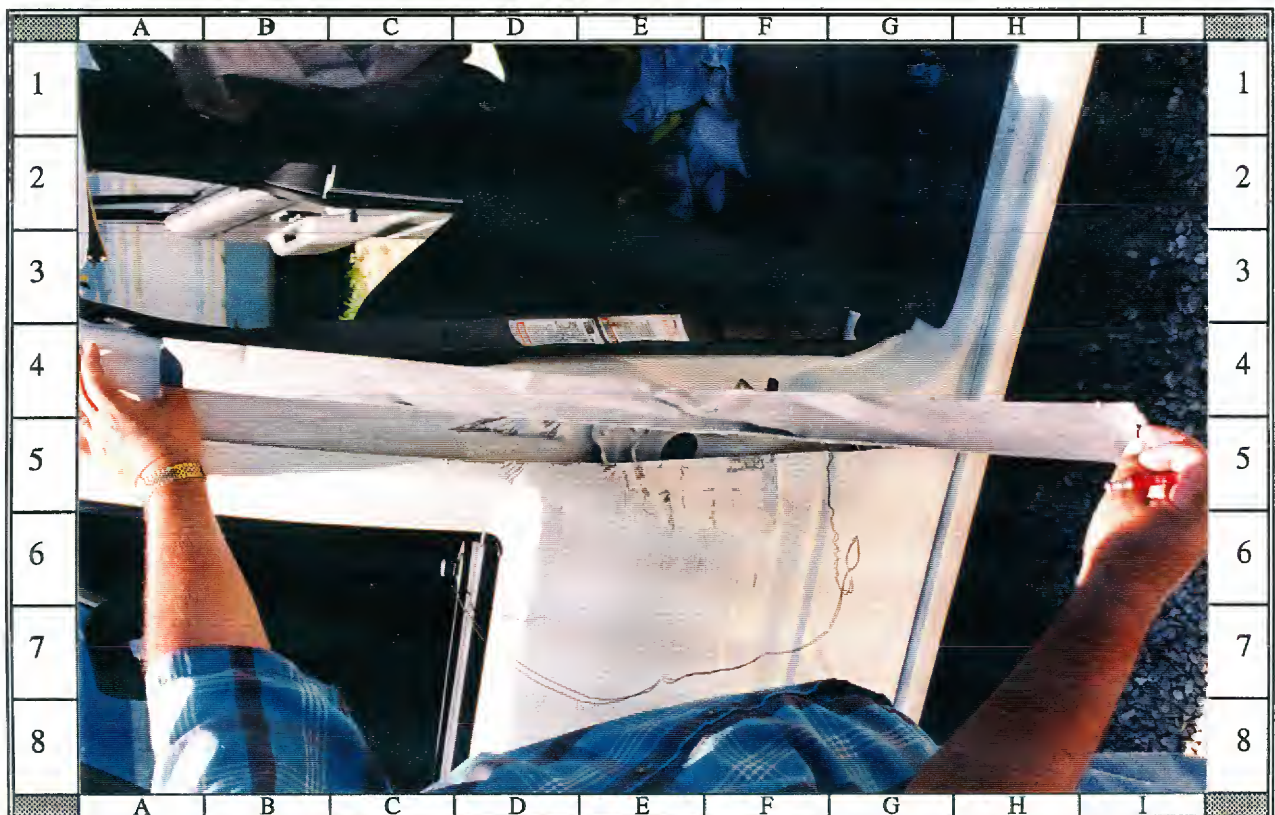
74: Underneath side of Case Vehicle's right front safety belt showing occupant load-ing stretch marks; NOTE: belt cut (cells I4--I5) by EMTs to enable extrication

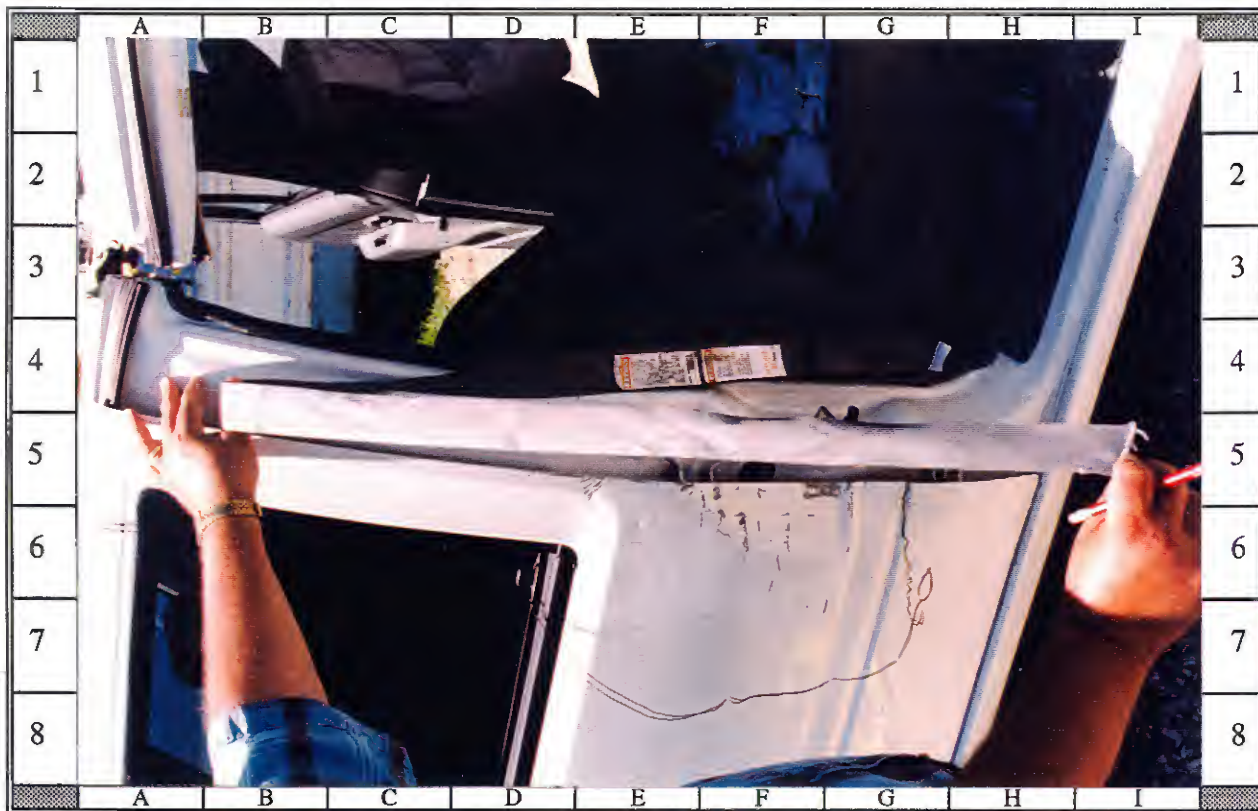
75: Top (cells B4--B5) side of Case Vehicle's right front safety belt showing occupant loading stretch marks; NOTE: extrication cut to right roof side rail

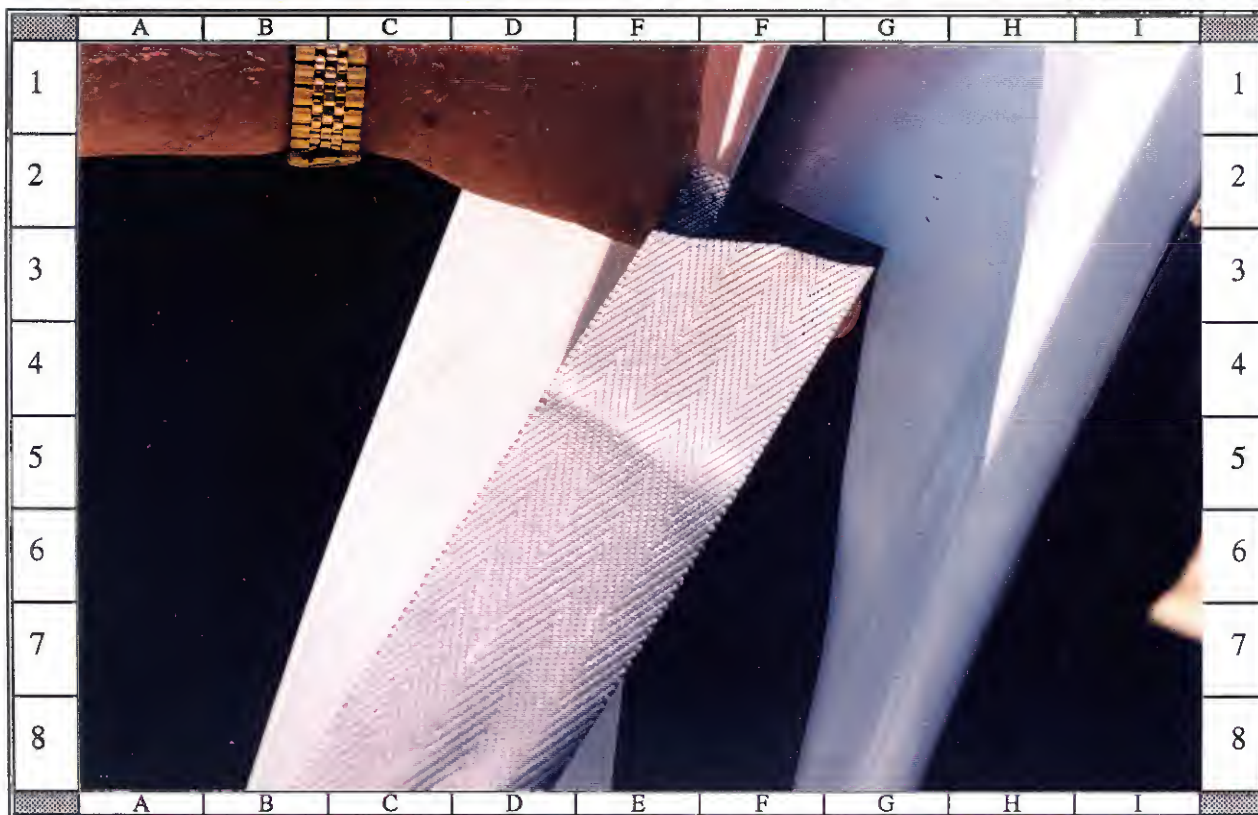
76: Close-up of top side of Case Vehicle's right front safety belt showing occupant loading crease from "D"-ring

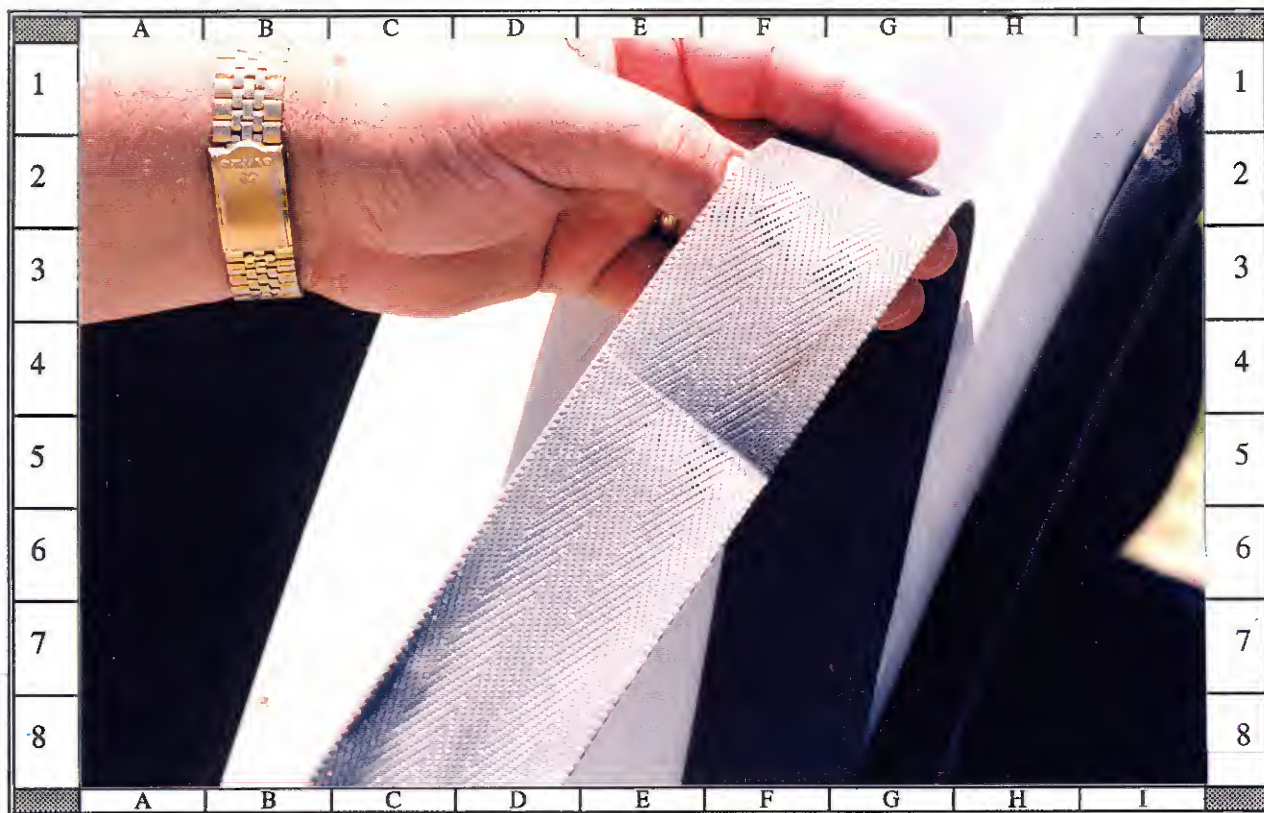
77: Close-up of underneath side of Case Vehicle's right front safety belt showing occupant loading crease from "D"-ring

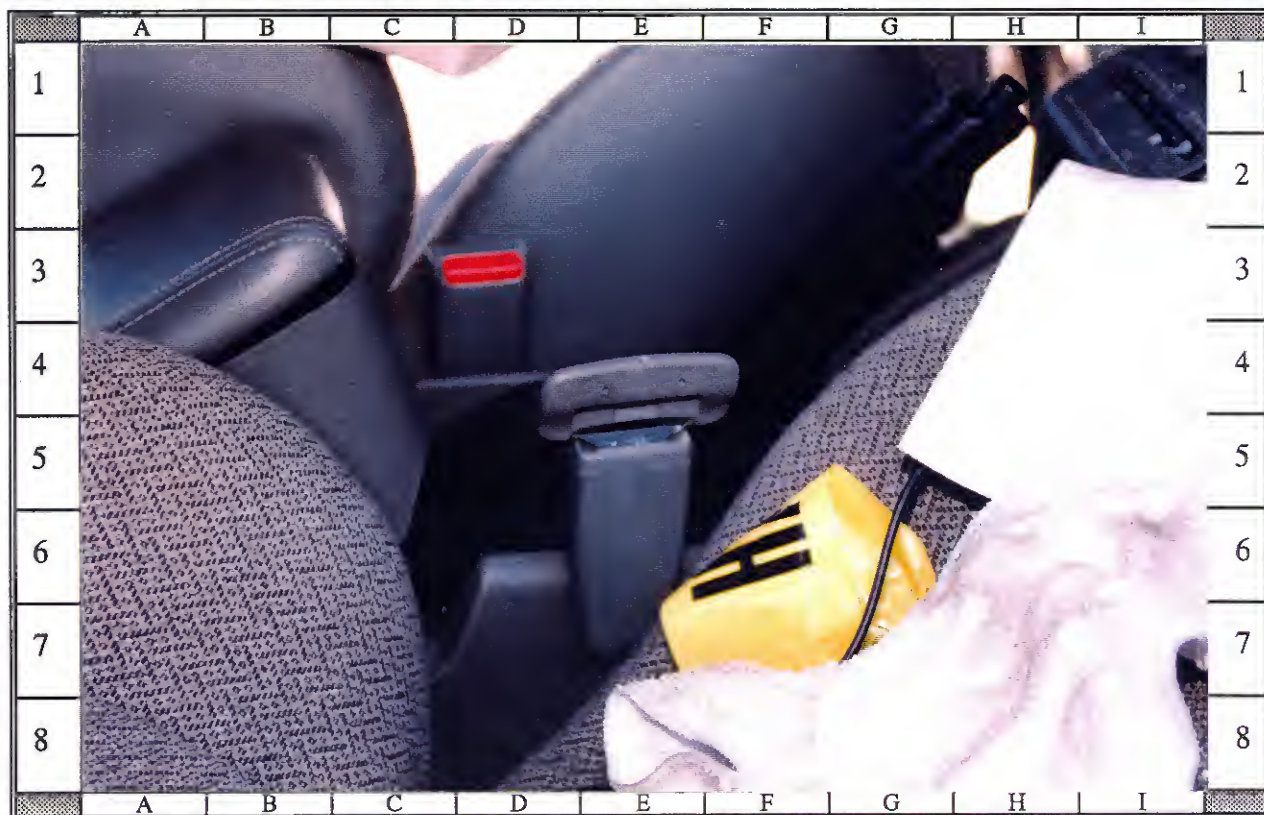
78: Close-up of Case Vehicle's right front safety belt latch assembly (i.e., connection of male and female ends) viewed from right; NOTE: belt cut for extrication

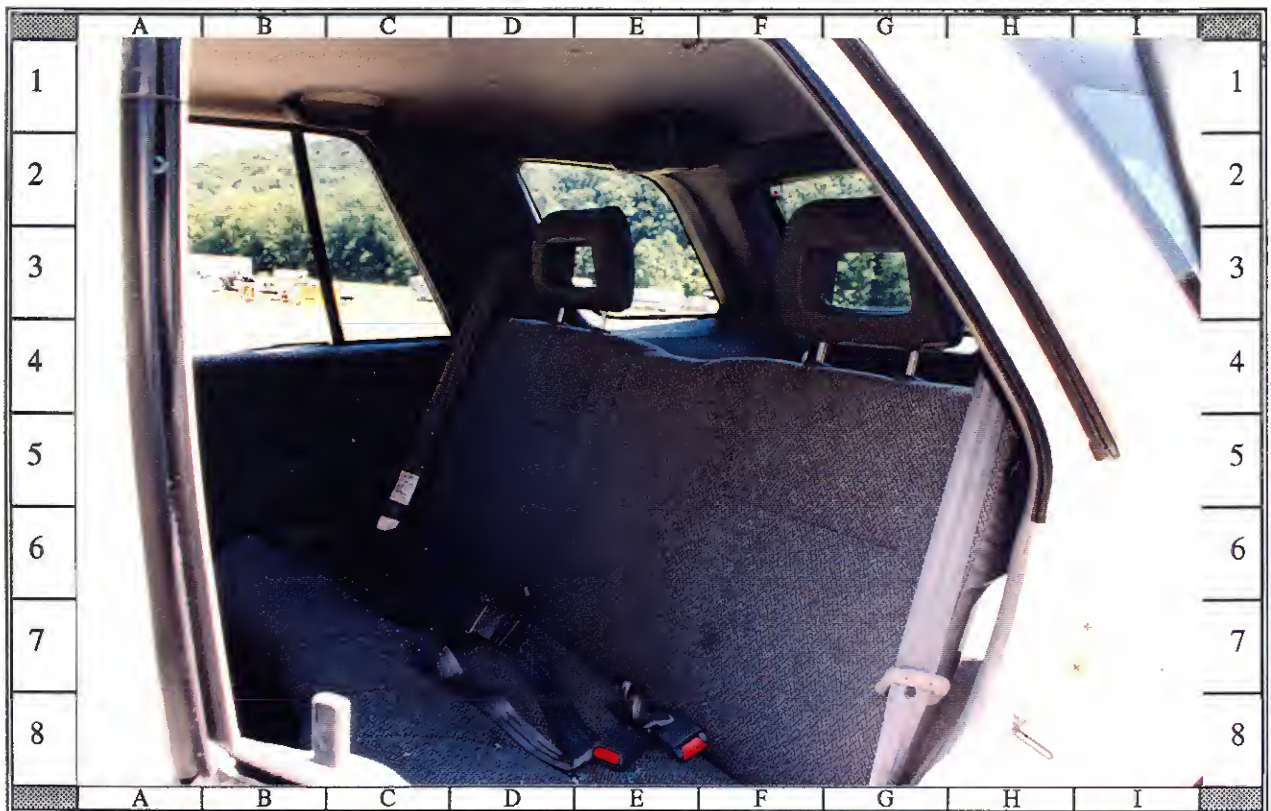
79: Case Vehicle's second seating area viewed through disintegrated left rear glazing showing outboard 3-point safety belts and adjustable head restraints

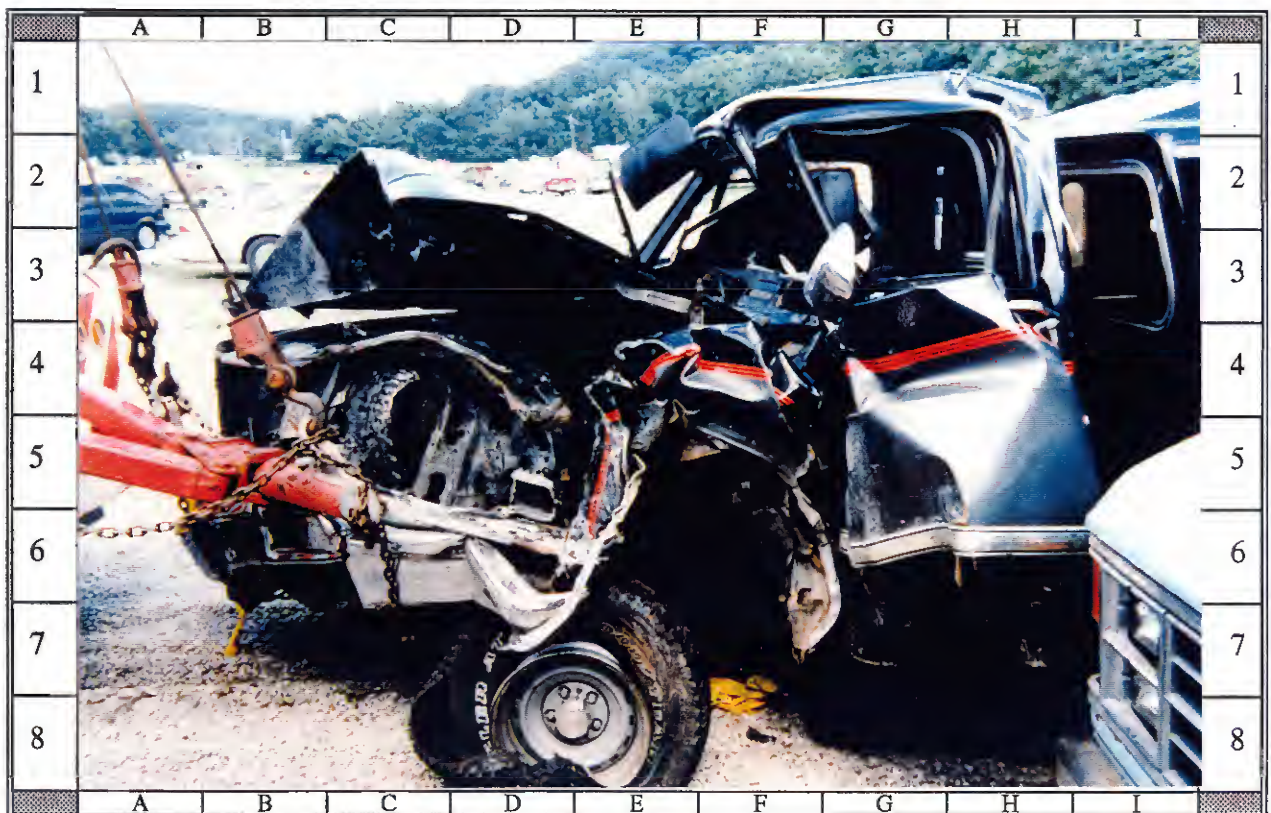
80: 1986 GMC pickup's (Vehicle #2's) damaged front viewed from left; NOTE: extent of crush and indirect damage to left "A"-pillar

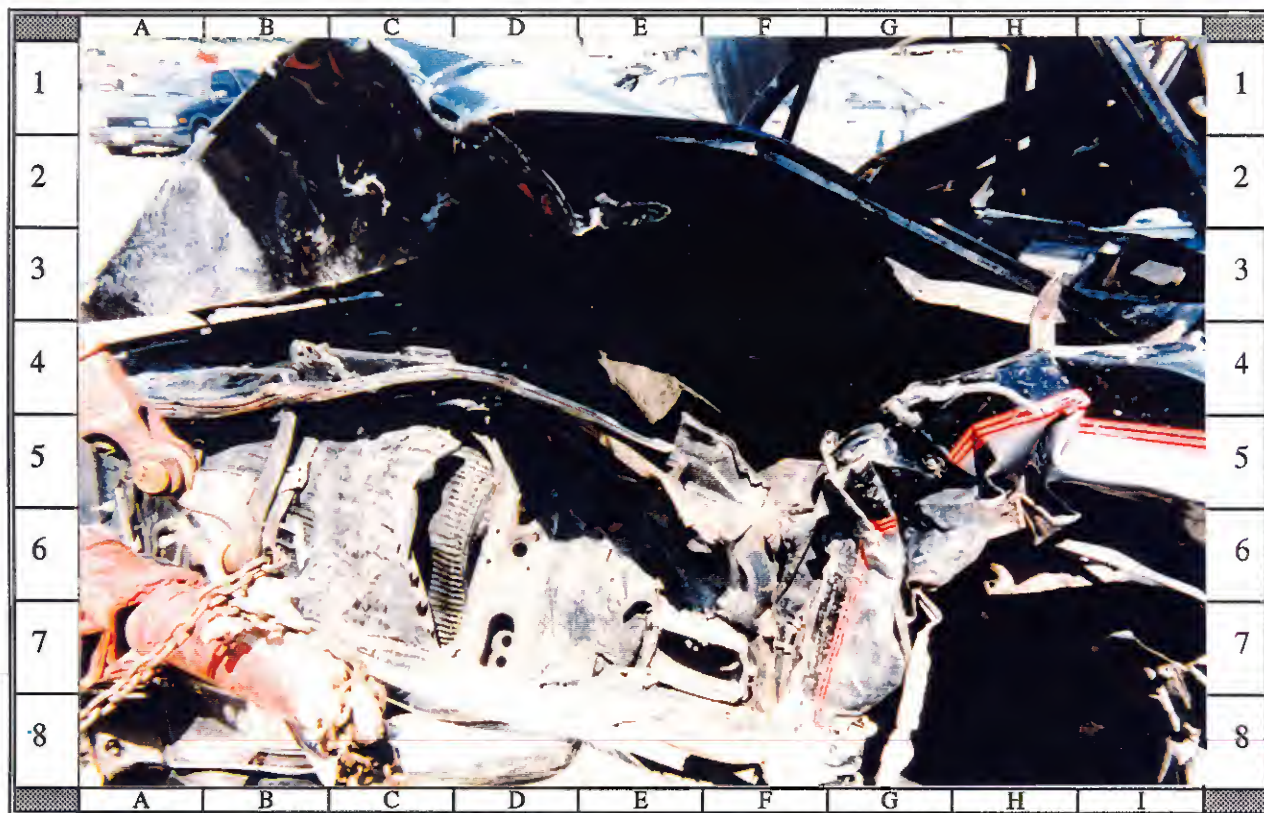
81: Close-up of Vehicle #2's damaged front viewed from approximate 30 degrees left of front; NOTE: orange metal at left of photo is wrecker's tow bar

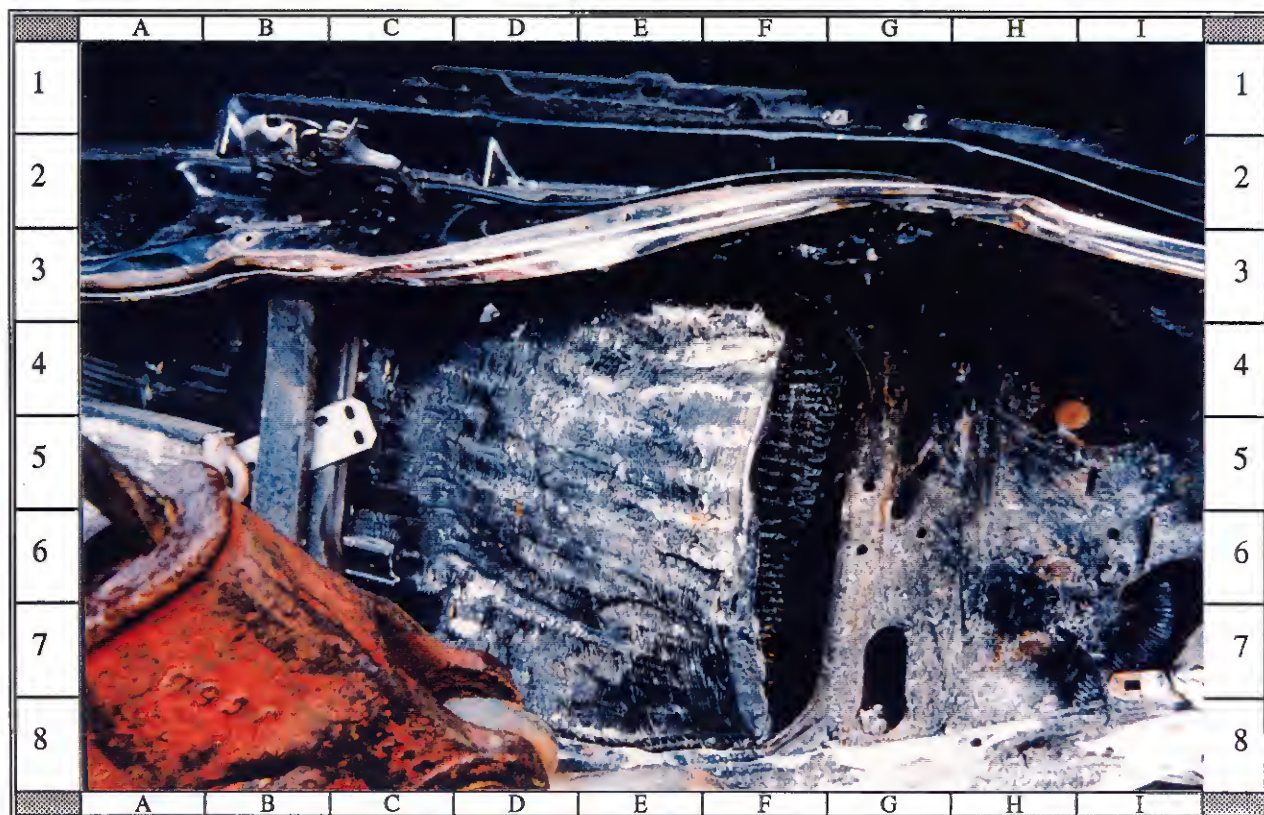
82: Close-up view of Vehicle #2's damage front center viewed from approximate 30 degrees left of front; NOTE: damage to hood latch and radiator

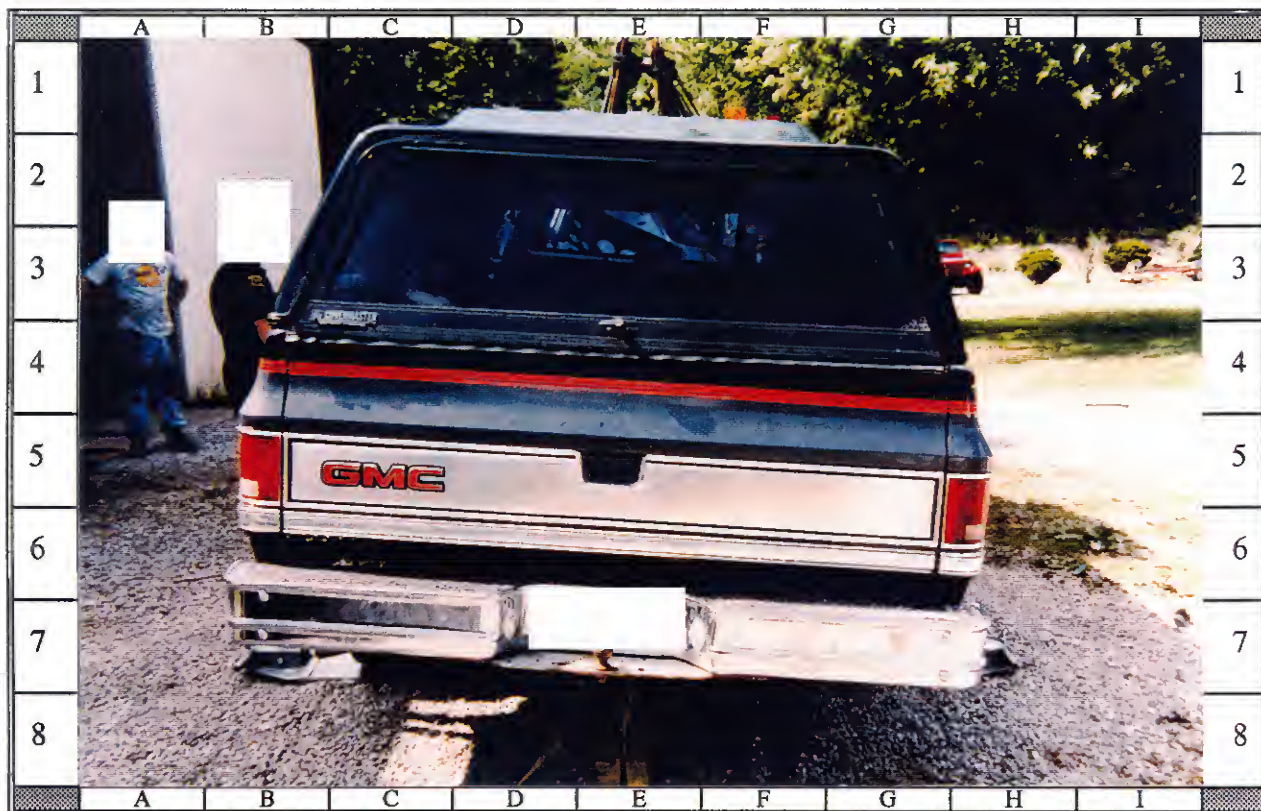
83: Vehicle #2's undamaged back showing attached half-shell camper top

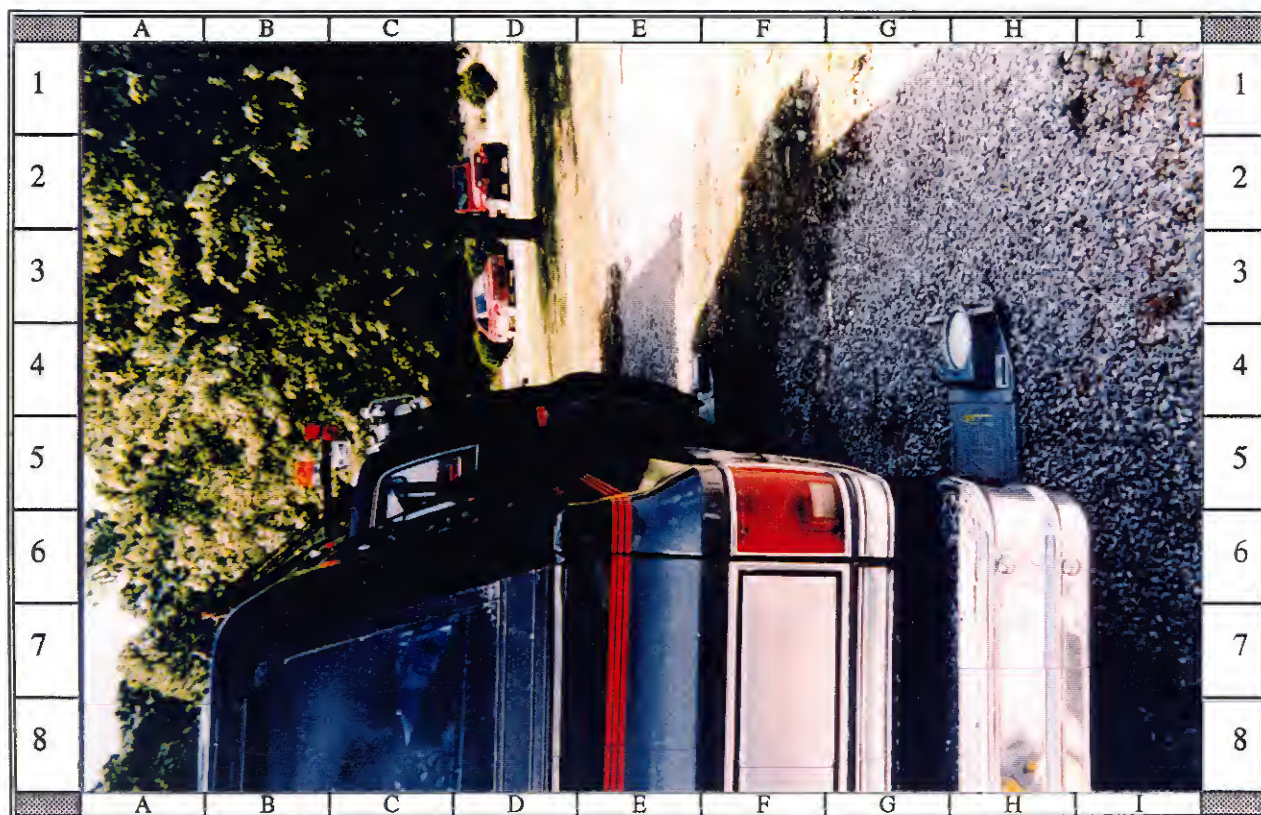
84: Reference line view of Vehicle #2's right side from rear showing extensive shifting of cab

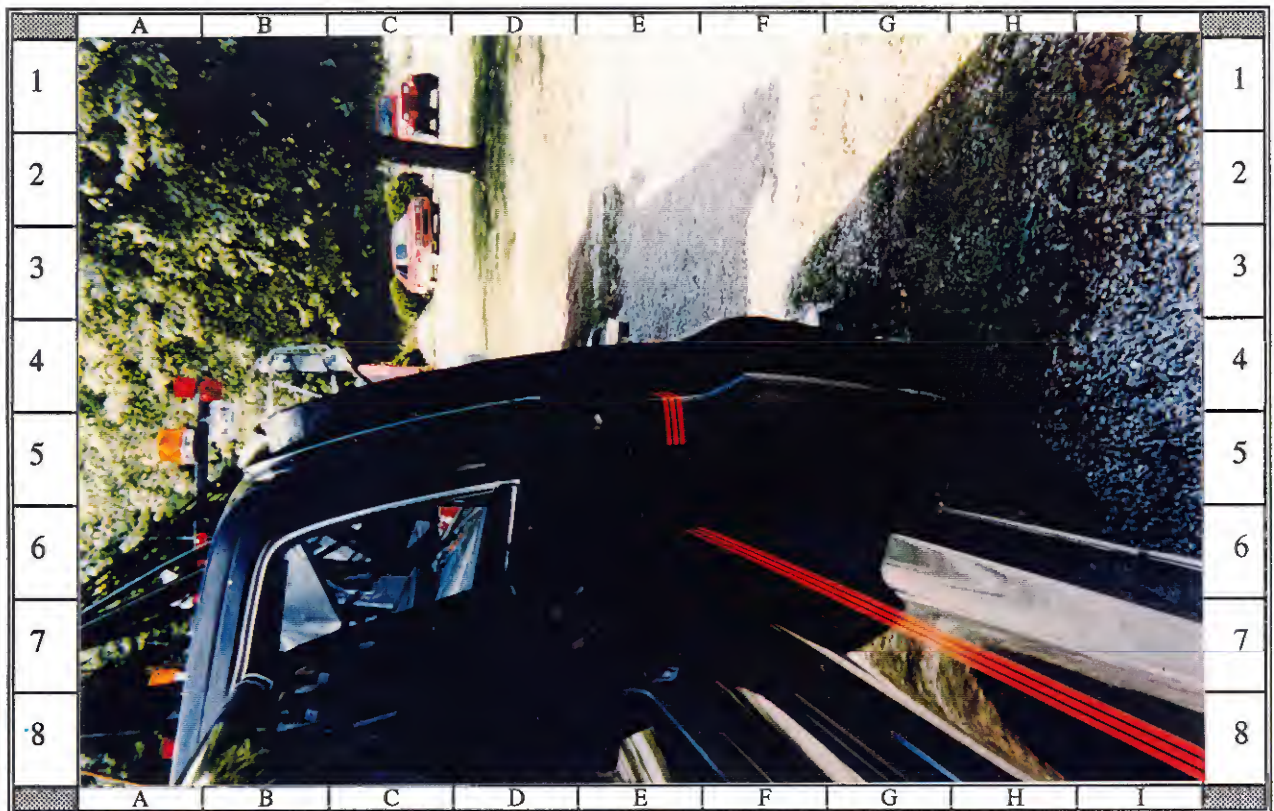
85: Close-up of Vehicle #2's left-to-right cab shift viewed from back; NOTE: extensive offset between cab and cargo bed

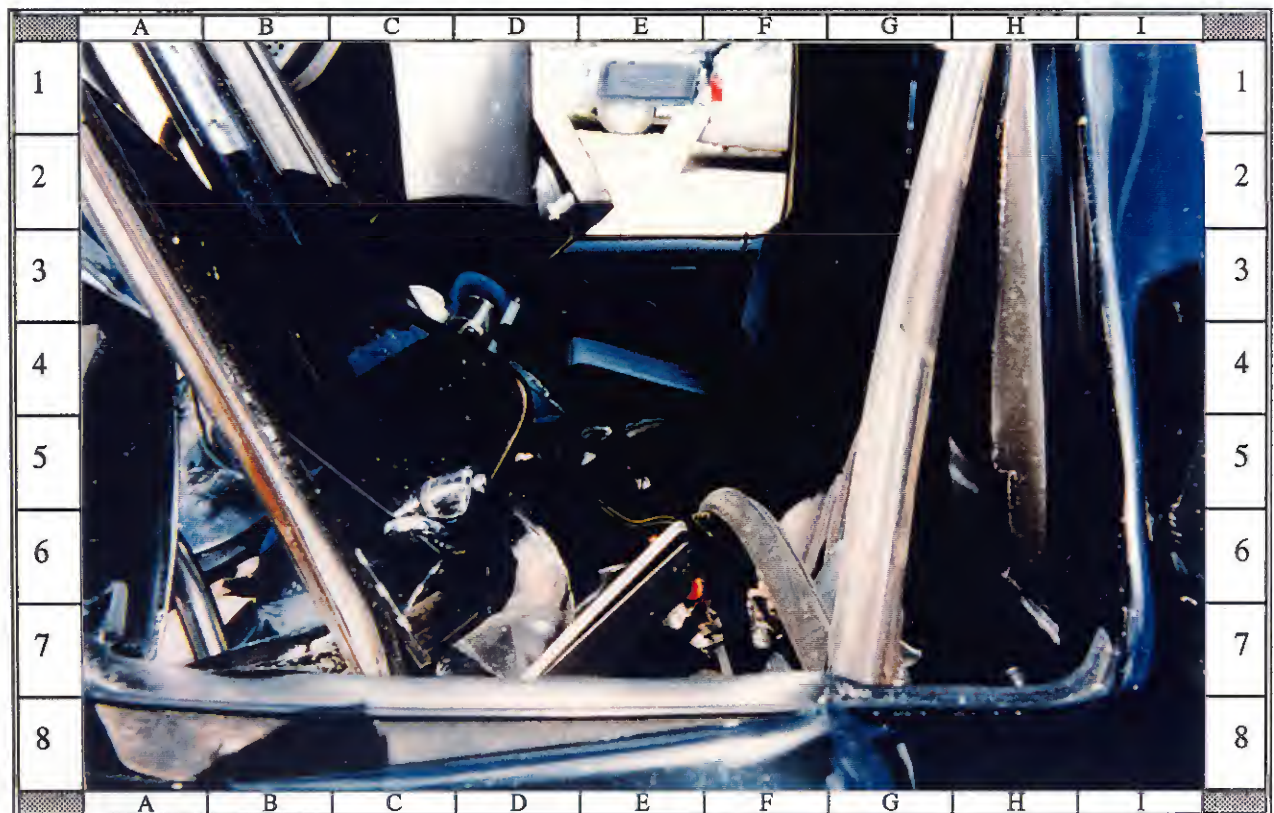
86: Vehicle #2's driver seating area viewed through the driver's disintegrated door glazing; NOTE: extensive intrusion into driver's space

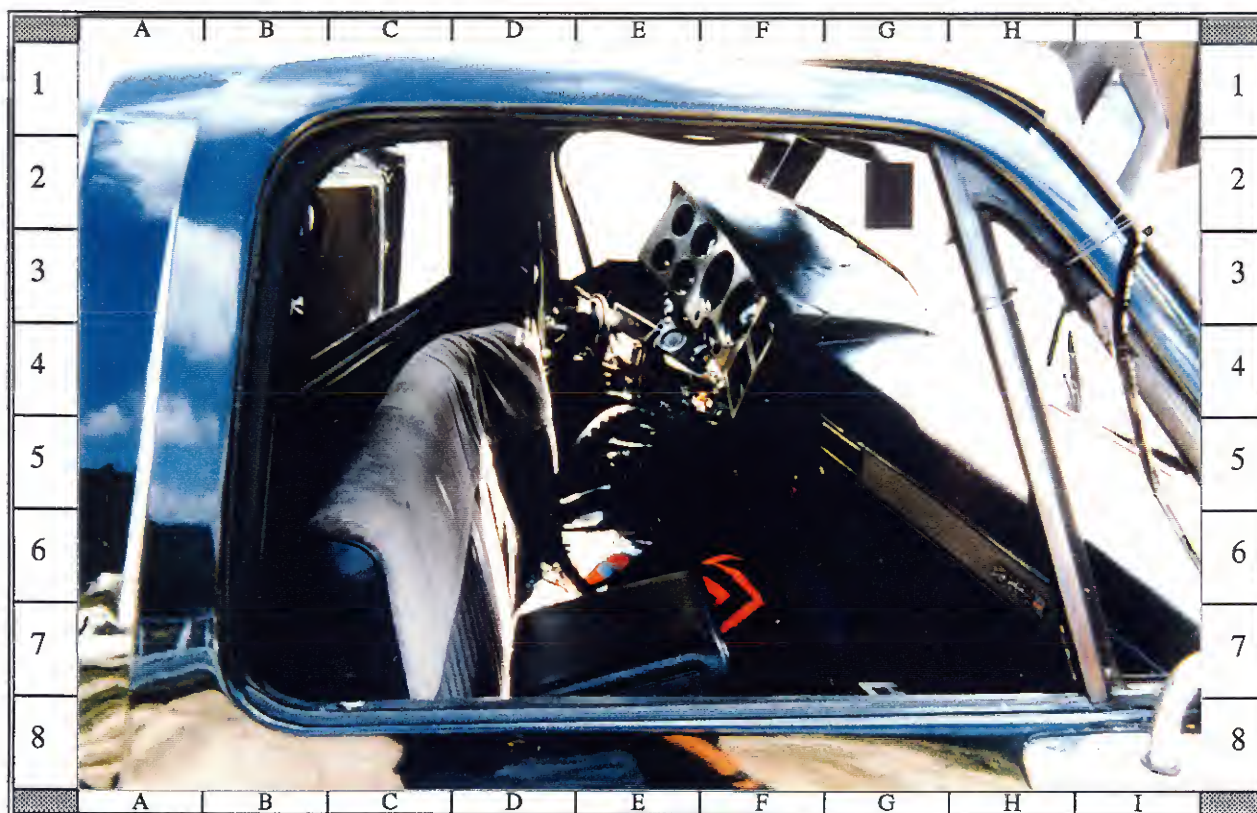
87: Vehicle #2's front bench seat viewed through right front passenger's disintegrated door glazing; NOTE: position of steering wheel and column and bent seatback

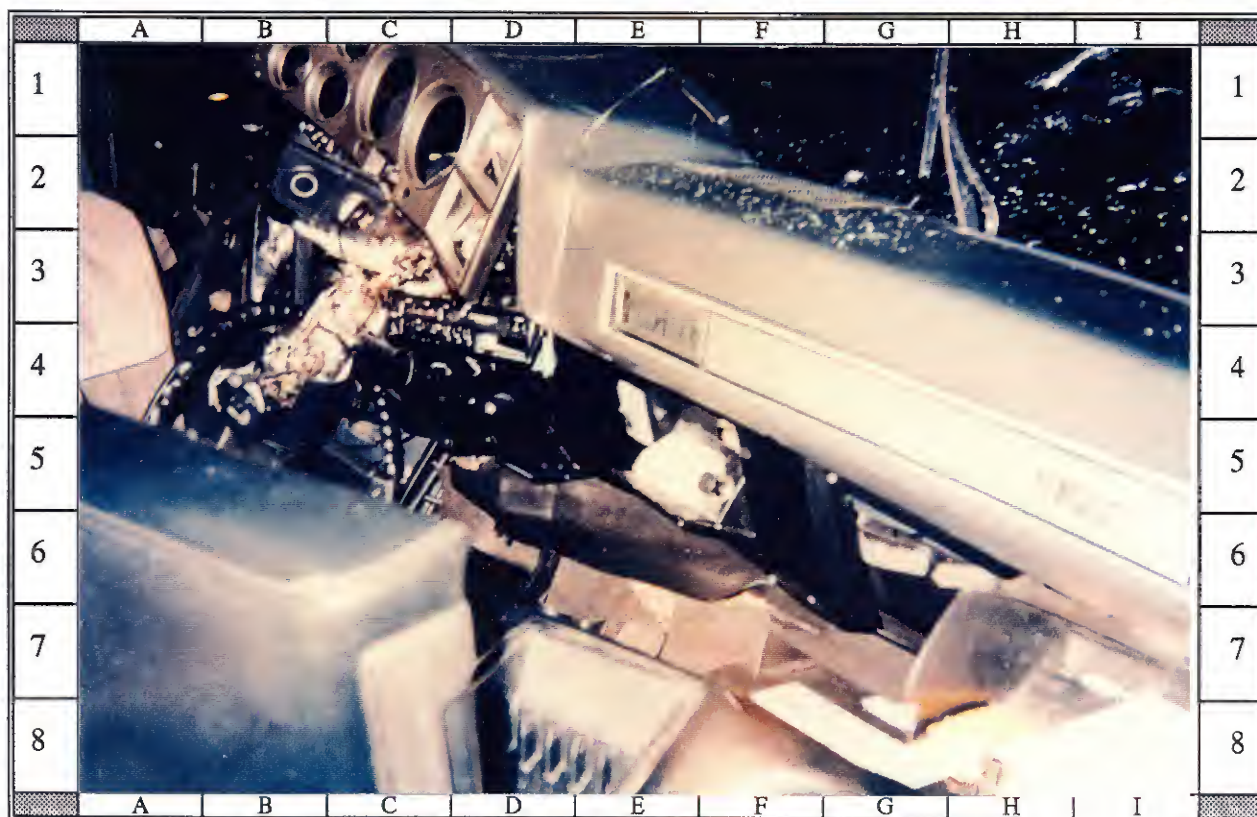
88: On-scene view of Vehicle #2's steering wheel, instrument panel, and dash area viewed through right side of backlight; NOTE: intrusion to driver seating area
